Service News Microscopy No. 03b/2009 Technical Service CM

May 25, 2009

Subject: USB-Problems at FSC 2. Generation

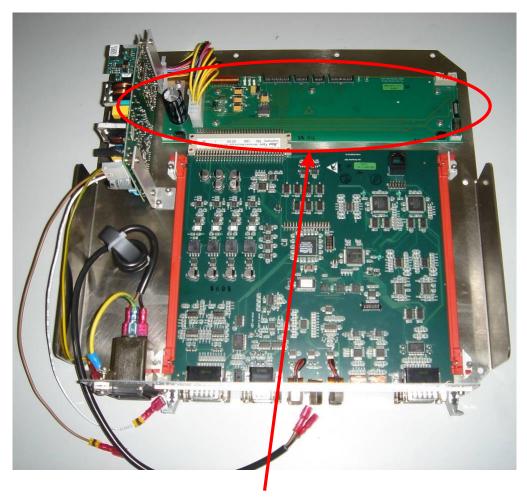
Image adapter board / Abbildung Adapterboard

During examinating these problems we found out that occasionally there were interference signals on the internal USB interface. These signals were caused by the implemented motor for the column.

- Adapter board 11 360 010 029 000 was tagged with ... / 05. (11-360-010-029 / 05)
- Basic distributor 11 360 010 016 000 was tagged with 127.700.000./02.

Adapter board 11 360 010 029 000

These errors were eliminated by changing the components on the boards adapter board 11 360 010 029 000 and basic distributor 11 360 010 016 000.

We ask you to check and if necessary to exchange the corresponding board in case of problems with the USB interface directly on site.

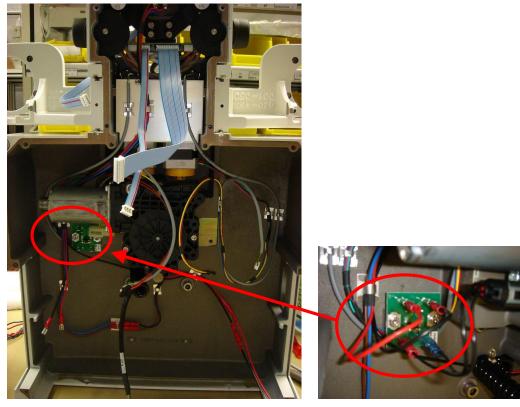
Image distributor board / Abbildung Entstörung

The adapter board is mounted on "Chassis complete" (see B 2.1 in service manual). The basic distributor is also easy reachable by removed "Chassis complete" (see images).

Basic distributor 11 360 010 016 000 Entstörung 11 360 010 016 000

(Basic distributor 11 360 010 016 000 is part of this, because of cost effectiveness it is not orderable as single part)
