## CERTIFICATE of QUALITY TEST

Test report-No. 5559 / 06

Client	<b>Spectra-Physics GmbH</b> Ruhlsdorfer Str. 95 14532 Stahnsdorf
Equipment under test	<b>Laser Head Controller</b>  manufacturing date <span style="float: right;">March 2006</span>
Purpose	<i>Test of the climatic resistance and of the dynamic-mechanical robustness according to the standards as well as to the demands of the client</i>
Test program	<i>Temperature Cycling Test</i> <span style="float: right;">- test Nb</span> <i>Heat and Humidity Storage Test</i> <span style="float: right;">- test Cab</span> <i>Drop Test</i> <span style="float: right;">- test Ed</span> <i>Vibration Test</i> <span style="float: right;">- test Fc</span> <i>Shock Test</i> <span style="float: right;">- test Ea</span>
Test period	March 17 <sup>th</sup> to March 24 <sup>th</sup> 2006
Realization / results	see page 2 to 8
Test result	<p>The tests were realized according to the standards and to the demands of the client.</p> <p>After the Temperature Cycling Test, the operability of the Laser Head "B" was not ensured.</p> <p>After the Heat and Humidity Storage Test, the operability of the Laser Head was not ensured.</p> <p>During the drop test, a

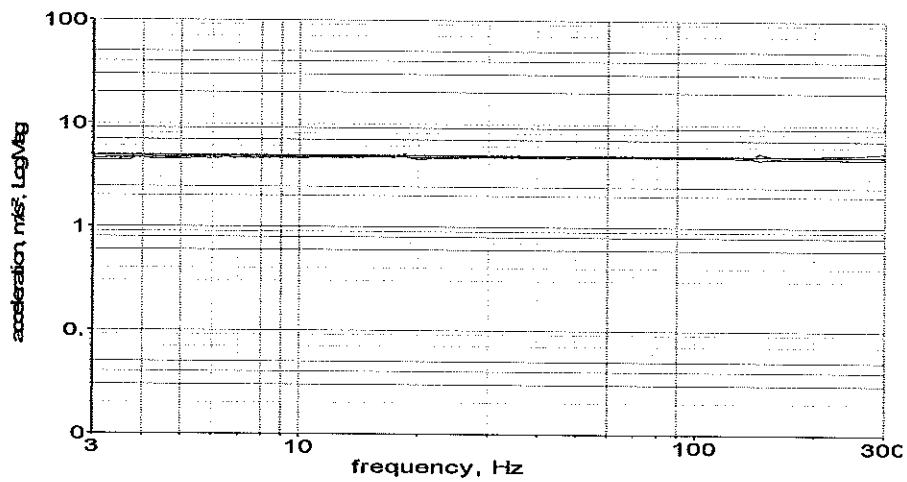
Vibration Test, X-axis, specimens not in package, 3 - 300 - 3 Hz, 4,905 m/s<sup>2</sup> (0,5 g)

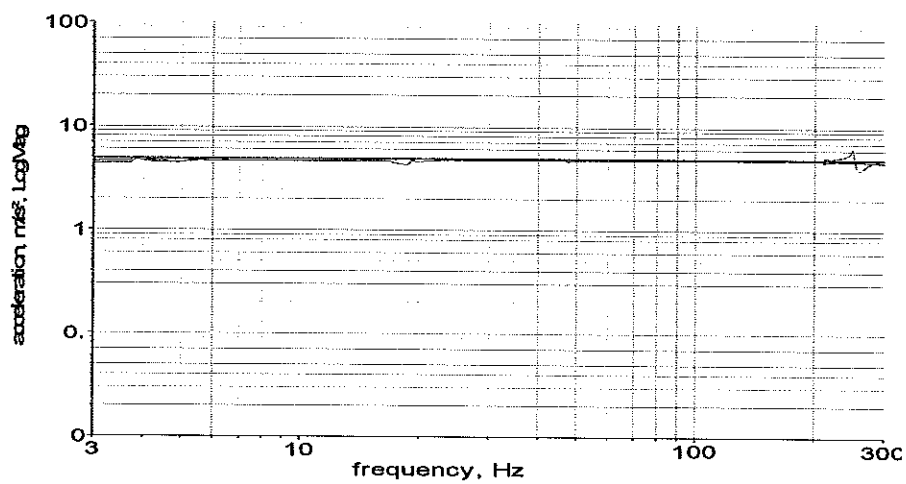
Vibration Test, Z-axis, specimens not in package, 3 - 300 - 3 Hz, 4,905 m/s<sup>2</sup> (0,5 g)

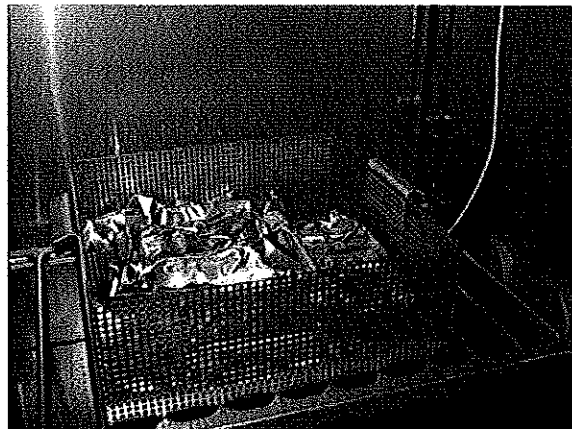
**picture 2**  
**Laser Heads A and B and Controller PS**  
**in temperature test chamber 10**  
*during test - Nb (-20°C/+50°C)*

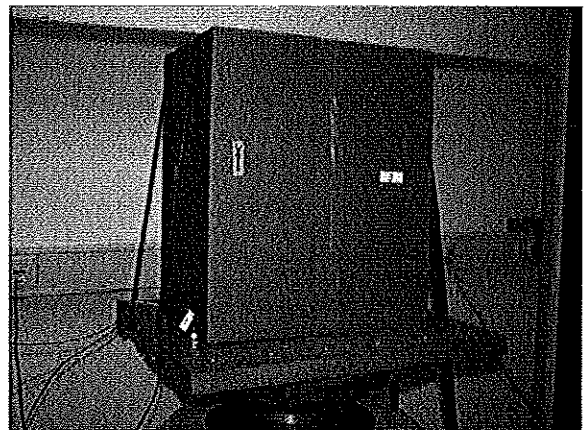
**picture 12**  
Specimens in package  
with accelerations sensors  
*during test Fc in Z-axis*

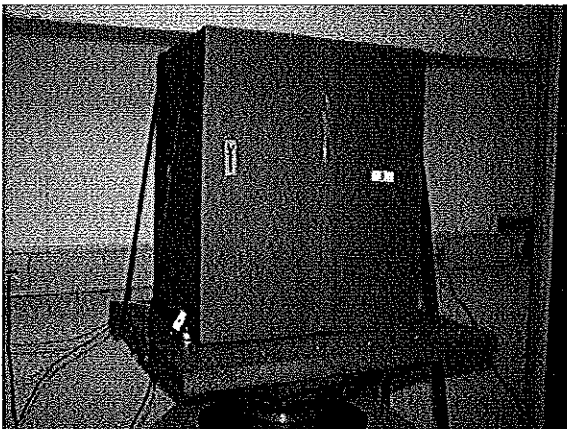
**picture 13**  
Specimens in package  
with accelerations sensors  
*during test Fc in X-axis*

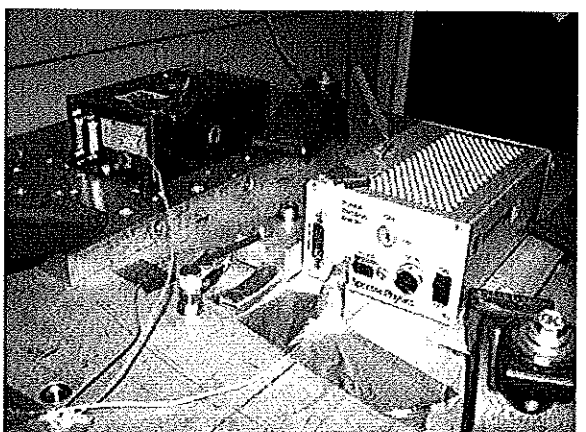
**picture 20**  
**Laser Head and Controller**  
**with accelerations sensors (arrows)**  
*during shock tests in Z- and Zi-axis*
