## Leica EM TIC020 –

### Cross Section of Glass Fibres Reinforced Polyamide

# Leica EM TIC020 Application No. 2/5

## Cross Section of Glass Fibre Reinforced Polyamide

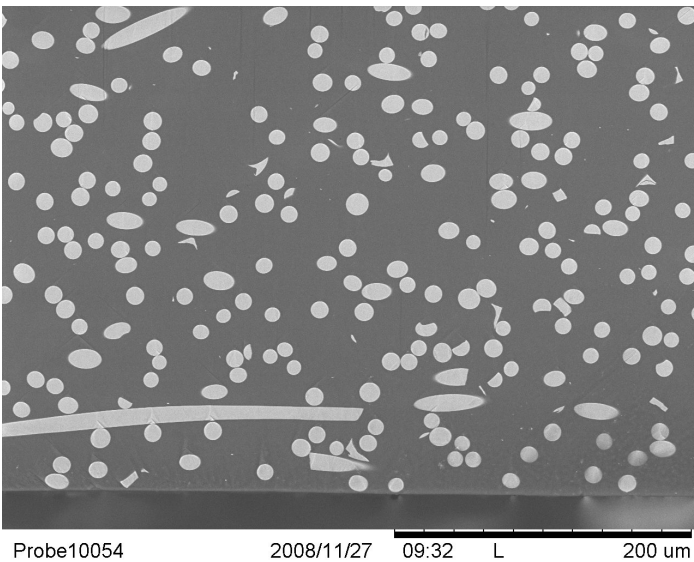
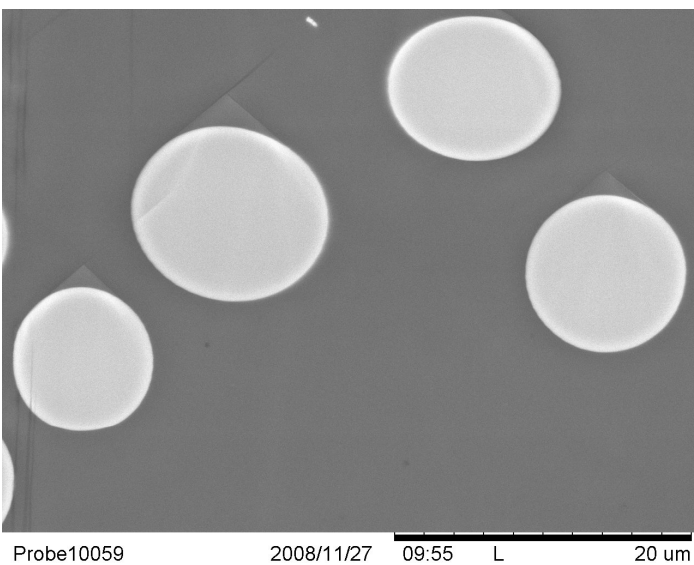
- No cracks are visible on single fibres in the cross section, which would occur by mechanical preparation.
- The image analysis can be done at a high accuracy level, as there are no cracks which would divide the glass fibre into surreal amount.

- The fragile glass fibre gets broken during mechanical polishing. A lot of cracks and broken fibres influence the image analysis.

Parameter	
Acceleration voltage	6 kV
Gun current	2.3mA
Milling time	2.5 h
Cut depth	300 µm
Pre-preparation	EM TXP (6µm diamond)
